ent 1-3 Filed 06/24/21 Page 2 of 5 Page D #: 107 NUMBER: 03-001-15 REV. A

GROUP: Differential & Driveline

Rear Half Shaft Vibration

2015	(LX) Chrysler 30	
2015	(LD)	Dodge Charger
2015	(LA)	Dodge Challenger

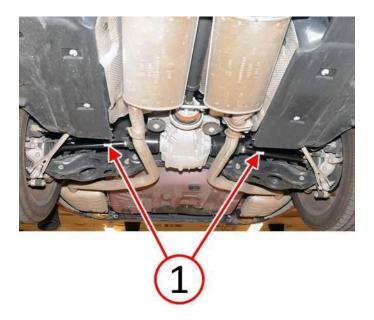
Fig. 1 Identification Label Location

1. **Raise the vehicle and locate the axle shaft identification labels (1) (Fig. 1). Refer to the detailed service procedures available in DealerCONNECT> TechCONNECT under: Service Info> 04 - Vehicle Quick Reference> Hoisting> Standard Procedure.**

1 - Identification Labels

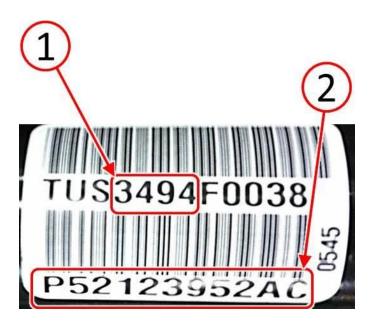
Fig. 2 Identification Label Information

2. **Inspect the affected date code range (1) on both axle shaft identification labels (Fig. 2).**

- 1 Date Code Range
- 2 Part Number

3. **Is the affected date code range any number between 3094 through 3384?

- a. YES>>> Continue with the Repair Procedure Step #4.
- b. NO>>> This bulletin has been completed, use LOP (03-20-03-92) to close the active RRT. If the customer described the symptom/condition listed above, normal diagnosis should be performed.**
- 4. Replace both rear half shafts. Refer to the detailed service procedures available in DealerCONNECT> TechCONNECT under: Service Info> 02 Differential and Driveline> Half Shaft> Removal/Installation.
